**Flood Control Project Maintenance  
Levee Inspections**  
**LMA District Cover Sheet**  
**Spring 2019 Levee Inspection Results**

**Reclamation District No. 0785 Driver**

**Spring 2019 Levee Inspection Results**

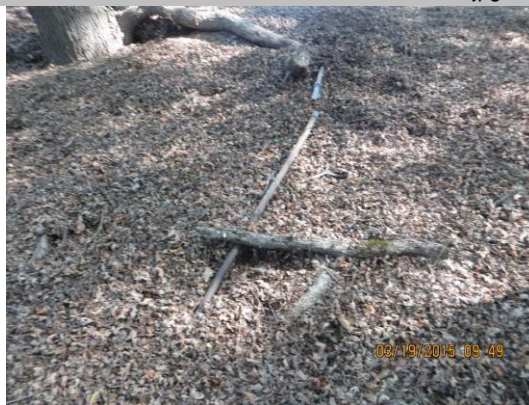
Photo 2 of 2 : UCIP\_SP\_2019\_43965\_73438.jpg

Pipe visible on LS slope.

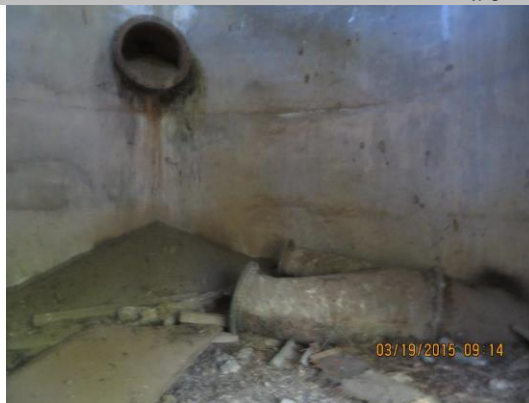
Photo 1 of 3 : UCIP\_SP\_2019\_53407\_73402.jpg

FS\_ID:53407  
DS\_ID:22974  
EP\_NO: N/A  
Repair Type: Non-Urgent  
Crossing Status: Found  
UCIP Comments: 07/17/2018 Unable to access pumphouse due to heavy vegetation. No integrity issue observed, therefore crossing downgraded to "Non-Urgent". Crossing is a part of DWR DMP Phase1 for internal video inspection. (O.Yakimov-DWR UCIP)07/18/2016 Same as last inspection. Pipe is silted in as visible through the LS pumphouse. (K. Fazel - UCIP)03/19/2015 Pipe appears to be abandoned and should be done so properly as it is open on the LS inside the pumphouse. Dense vegetation on both sides of the levee. (G. Wylie - FPIIB)  
FIELD\_STRUCT\_DESC: \*ABANDONED\* 30-inch steel pipe of an unknown purpose through the levee, 10 feet below the crown. Landside (LS) end open inside a concrete pump house on the LS shoulder. Unable to find the pipe on the waterside (WS). [Additional Reference(s): DWR Levee Log, 1988. USACE Sacramento O&M Manual 122.1, August 1955, (RM 70.05), 18-inch pipe referenced, invert elevation 33.4 feet].

Pipe open at base of concrete building on LS shoulder. No pump found.

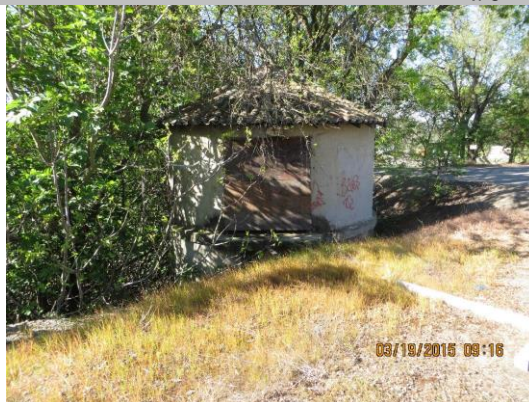
Photo 2 of 3 : UCIP\_SP\_2019\_53407\_73401.jpg

Pumphouse on LS shoulder.

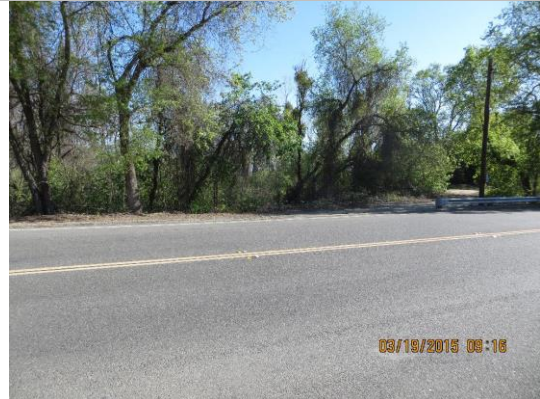
Photo 3 of 3 : UCIP\_SP\_2019\_53407\_73400.jpg

WS shoulder heavily vegetated. unable to search for pipe.

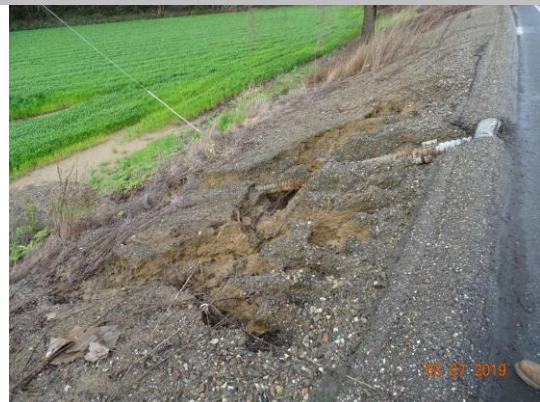
Photo 1 of 6 : SP\_2019\_RD0785\_185\_9\_20190311\_00040.jpg

LM Start	0.11	Rating **	U	Issue No.	9
LM End	0.11	Issue Type +	Ma	Location *	LS
Category	Earthen Levee			GPS Latitude/Longitude	
				Start	End
Item	Erosion / Bank Caving			38.660211 °	38.660211 °
				-121.611748 °	-121.611748 °
DWR ID	DWR_RD0785_01_f_2017_9				
Comment Code					
E2 : Schedule repair of erosion site prior to the next inspection.					
Inspector Comment					
Runoff erosion on landside slope that has gotten worse.

View of erosion on the landside slope. Spring 2019.

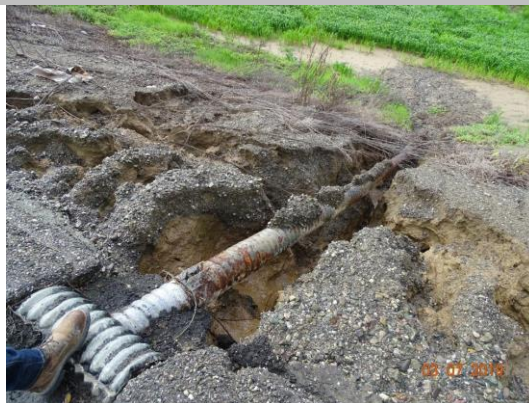
Photo 2 of 6 : SP\_2019\_RD0785\_185\_9\_20190311\_00041.jpg

View of erosion on the landside slope. Spring 2019.

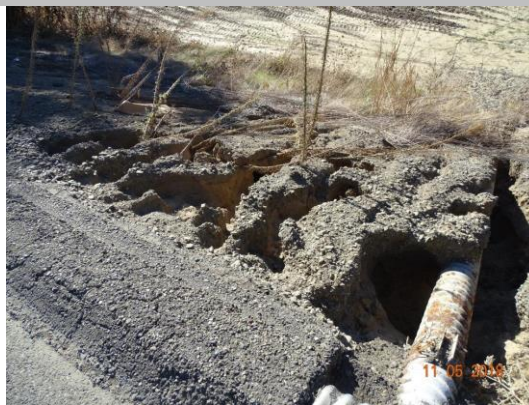
Photo 3 of 6 : SP\_2019\_RD0785\_185\_9\_20190304\_00003.jpg

View of erosion on the landside slope. Fall 2018.

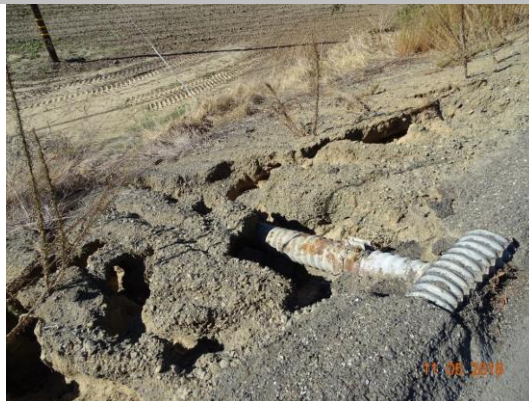
Photo 4 of 6 : SP\_2019\_RD0785\_185\_9\_20190304\_00004.jpg

Additional view of erosion on the landside slope. Fall 2018.

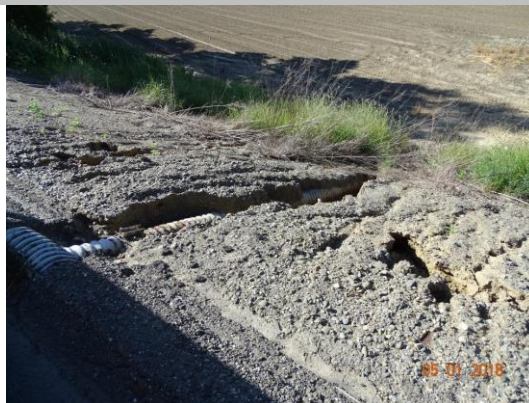
Photo 5 of 6 : SP\_2019\_RD0785\_185\_9\_20190304\_00006.jpg

View of runoff on the landside slope. Spring 2018.

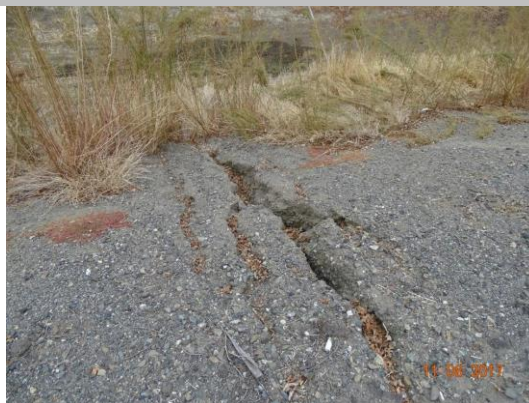
Photo 6 of 6 : SP\_2019\_RD0785\_185\_9\_20190304\_00007.jpg

View of runoff erosion on the landside slope. Fall 2017.

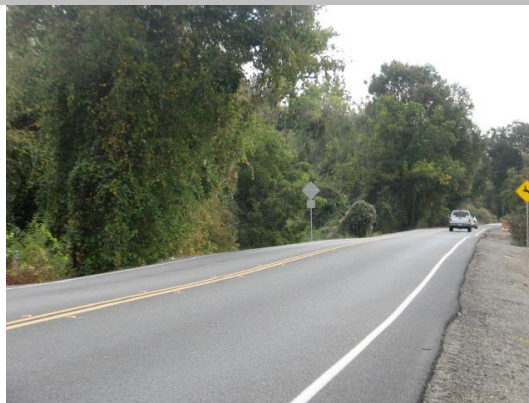
Photo 1 of 2 : SP\_2019\_RD0785\_185\_16\_20190304\_00012.jpg

LM Start	0.21	Rating **	M	Issue No.	16
LM End	1.21	Issue Type +	Ma	Location *	WS
Category	Earthen Levee			GPS Latitude/Longitude	
				Start	End
Item	Vegetation			38.659340 °	38.647805 °
				-121.610405 °	-121.600076 °
DWR ID	DWR_RD0785_01_f_2013_16				
Comment Code					
V2 : Remove the wild growth other than native grasses from the levee slopes.					
Inspector Comment

Brush and other vegetation partially blocks visibility or access to the levee slope. Fall 2013

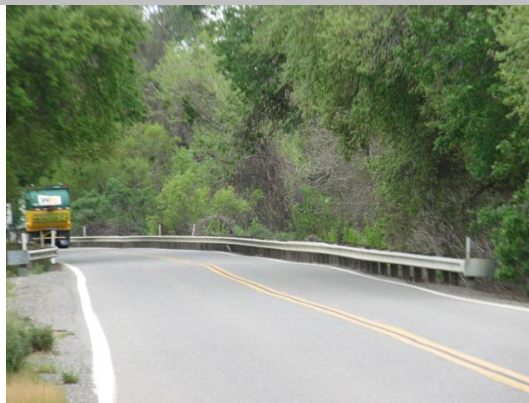
Photo 2 of 2 : SP\_2019\_RD0785\_185\_16\_20190304\_00013.jpg

Brush and other vegetation partially blocks visibility. Spring 2014

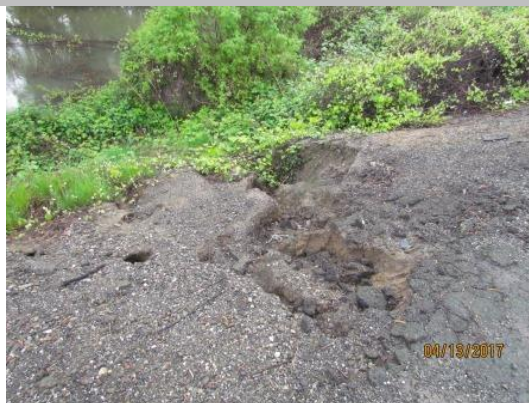
Photo 1 of 1 : SP\_2019\_RD0785\_185\_24\_20190304\_00015.jpg

LM Start	0.24	Rating **	M	Issue No.	24
LM End	0.24	Issue Type +	Ma	Location *	WS
Category	Earthen Levee			GPS Latitude/Longitude	
				Start	End
Item	Erosion / Bank Caving			38.658998 °	38.658998 °
				-121.610081 °	-121.610081 °
DWR ID	DWR_RD0785_01_s_2017_24				
Comment Code					
E2 : Schedule repair of erosion site prior to the next inspection.					
Inspector Comment					
Runoff erosion on waterside slope.

Runoff erosion on waterside levee slope. Spring 2017.

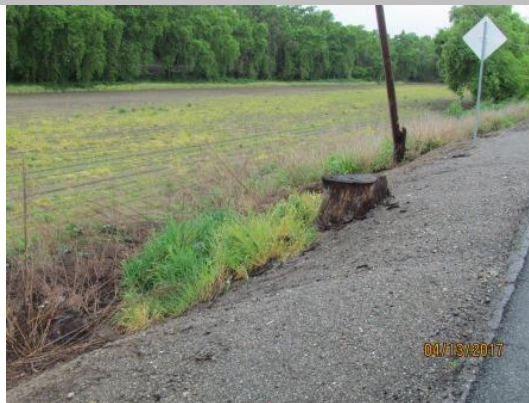
Photo 1 of 1 : SP\_2019\_RD0785\_185\_36\_20190304\_00020.jpg

LM Start	0.28	Rating **	N	Issue No.	36
LM End	0.28	Issue Type +	Ma	Location *	LS
Category	Earthen Levee			GPS Latitude/Longitude	
				Start	End
Item	Trim / Thin Trees			38.658537 °	38.658537 °
				-121.609675 °	-121.609675 °
DWR ID	DWR_RD0785_01_s_2017_36				
Comment Code					
T5 : Tree stumps.					
Inspector Comment

View of stump on landside levee slope. Spring 2017.

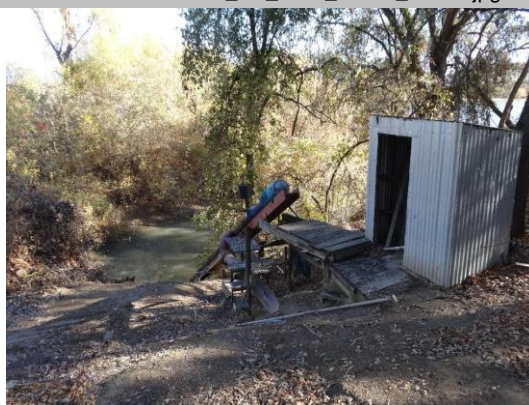
Photo 1 of 3 : UCIP\_SP\_2019\_43963\_45628.jpg

LM Start	0.63	Rating **	M	Issue No.	359
LM End	0.63	Issue Type +	En	Location *	
Category	Supplemental			GPS Latitude/Longitude	
				Start	End
Item	DWR UCIP Field Study			38.654641 °	38.654641 °
				-121.605538 °	-121.605538 °
DWR ID	22982				
Comment Code					
Inspector Comment					
FS_ID:43963					
DS_ID:22982					
EP_NO: N/A					
Repair Type: Non-Urgent					
Crossing Status: Found					
UCIP Comments: Part of abandoned pipe also found on waterside that should be removed.No access to landside across the highway.					
FIELD_STRUCT_DESC: 2 of 2: 0.75-inch steel electrical conduit through the levee, 1 foot below the crown. [Additional Reference(s):					
DWR Levee Log, 1988].					
FS Date: 11/21/2013

WS view: slant pump, walkway, and electric control box in shed on levee slope.

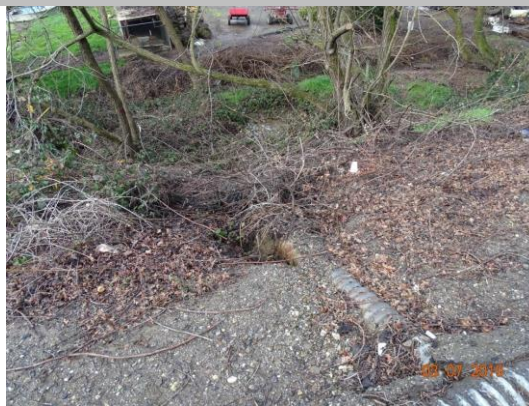
Photo 1 of 1 : SP\_2019\_RD0785\_185\_22\_20190311\_00042.jpg

LM Start	0.64	Rating **	M	Issue No.	22
LM End	0.64	Issue Type +	Ma	Location *	LS
Category	Earthen Levee			GPS Latitude/Longitude	
				Start	End
Item	Erosion / Bank Caving			38.654294 °	38.654294 °
				-121.605949 °	-121.605949 °
DWR ID	DWR_RD0785_01_s_2019_22				
Comment Code					
E2 : Schedule repair of erosion site prior to the next inspection.					
Inspector Comment					
Erosion around drainage pipe.

View of erosion on the landside slope. Spring 2019.

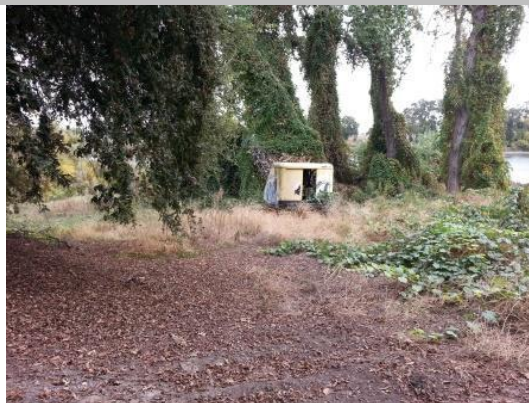
Photo 1 of 1 : SP\_2019\_RD0785\_185\_49\_20190304\_00022.jpg

LM Start	0.68	Rating **	M	Issue No.	49
LM End	0.68	Issue Type +	En	Location *	WS
Category	Earthen Levee			GPS Latitude/Longitude	
				Start	End
Item	Encroachments			38.654144 °	38.654144 °
				-121.605117 °	-121.605117 °
DWR ID	DWR_RD0785_01_f_2016_49				
Comment Code					
EQ : Equipment					
Inspector Comment					
Abandoned crane on waterward side.

View of an abandoned crane on waterward side of the levee. Fall 2016.

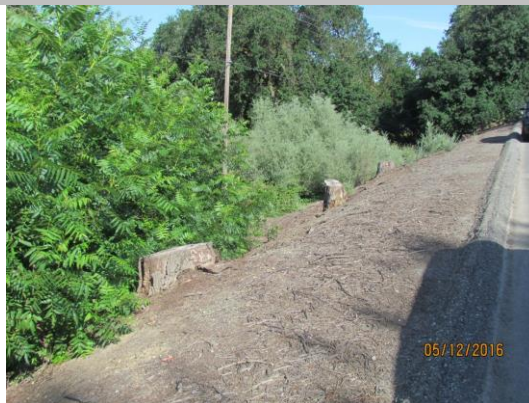
Photo 1 of 1 : SP\_2019\_RD0785\_185\_181\_20190304\_00025.jpg

View of the tree stumps on the landward side of the levee looking upstream. Spring 2016.

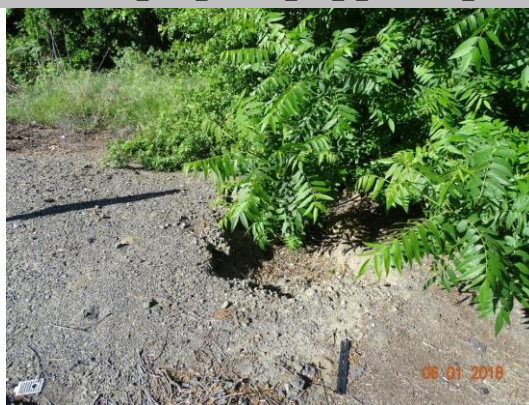
Photo 1 of 1 : SP\_2019\_RD0785\_185\_4\_20190304\_00001.jpg

LM Start	0.77	Rating **	M	Issue No.	4
LM End	0.77	Issue Type +	Ma	Location *	LS
Category	Earthen Levee			GPS Latitude/Longitude	
				Start	End
Item	Erosion / Bank Caving			38.652825 °	38.652825 °
				-121.604920 °	-121.604920 °
DWR ID	DWR_RD0785_01_s_2018_4				
Comment Code					
E1 : Note and monitor erosion site.					
Inspector Comment					
Runoff on landside slope.

View of runoff erosion on the landside slope. Spring 2018.

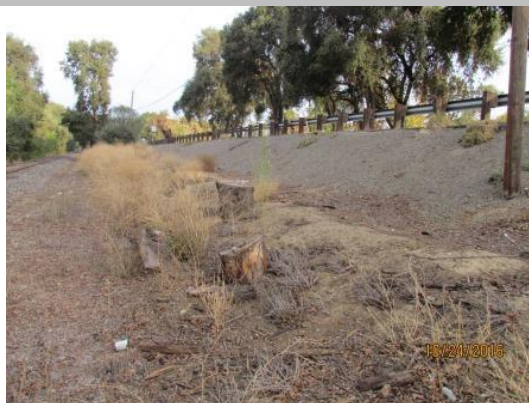
Photo 1 of 1 : SP\_2019\_RD0785\_185\_28\_20190304\_00016.jpg

Two tree stumps near levee toe on landside. Fall 2016.

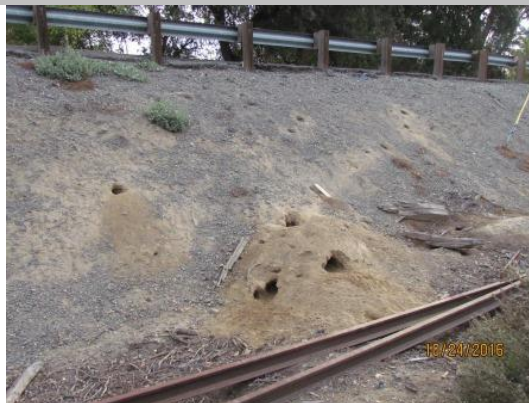
Photo 1 of 2 : SP\_2019\_RD0785\_185\_29\_20190304\_00017.jpg

LM Start	1.02	Rating **	M	Issue No.	29
LM End	1.02	Issue Type +	Ma	Location *	LS
Category	Earthen Levee			GPS Latitude/Longitude	
				Start	End
Item	Animal Control			38.649798 °	38.649798 °
				-121.602373 °	-121.602373 °
DWR ID	DWR_RD0785_01_f_2016_29				
Comment Code					
A3 : No rodents visible, but rodent burrows visible; need to backfill and compact or grout burrows.					
Inspector Comment					
Rodent holes on the landside slope.

View of rodent holes on LS slope. Fall 2016.

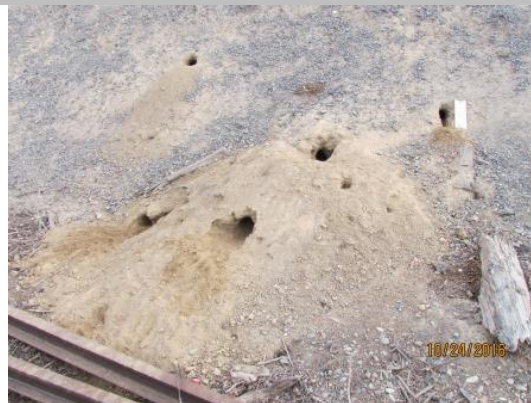
Photo 2 of 2 : SP\_2019\_RD0785\_185\_29\_20190304\_00018.jpg

Another view of rodent holes. Fall 2016.

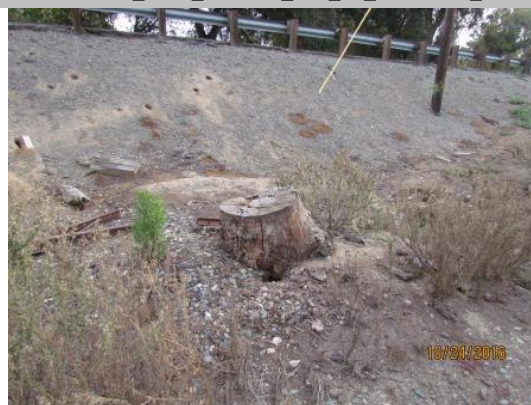
Photo 1 of 1 : SP\_2019\_RD0785\_185\_30\_20190304\_00019.jpg

LM Start	1.02	Rating **	N	Issue No.	30
LM End	1.02	Issue Type +	Ma	Location *	LS
Category	Earthen Levee			GPS Latitude/Longitude	
				Start	End
Item	Trim / Thin Trees			38.649775 °	38.649775 °
				-121.602363 °	-121.602363 °
DWR ID	DWR_RD0785_01_f_2016_30				
Comment Code					
T5 : Tree stumps.					
Inspector Comment					
Tree stump near levee toe

View of a stump near levee toe on landside. Fall 2016.

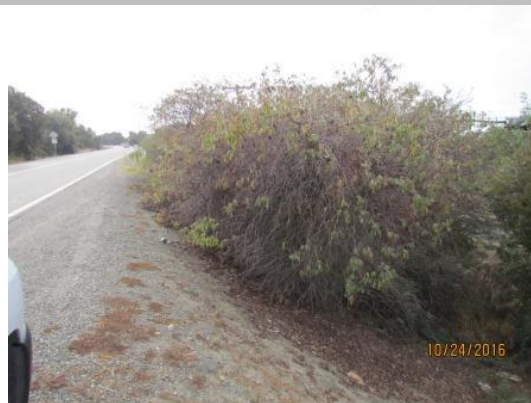
Photo 1 of 1 : SP\_2019\_RD0785\_185\_6\_20190304\_00002.jpg

View of elderberry trees on LS slope. Fall 2016.

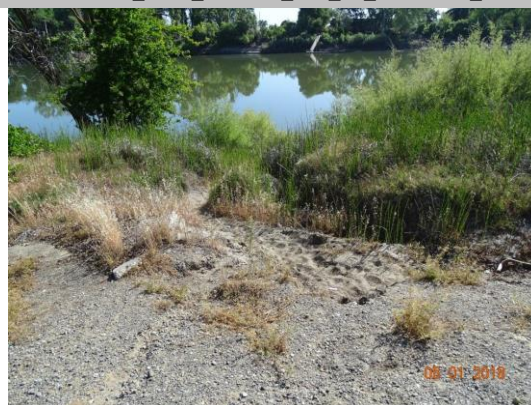
Photo 1 of 4 : SP\_2019\_RD0785\_185\_13\_20190304\_00008.jpg

LM Start	1.31	Rating **	M	Issue No.	13
LM End	1.31	Issue Type +	Ma	Location *	WS
Category	Earthen Levee			GPS Latitude/Longitude	
				Start	End
Item	Slope Stability			38.646652 °	38.646652 °
				-121.598907 °	-121.598907 °
DWR ID	DWR_RD0785_01_s_2013_13				
Comment Code					
S2 : Repair the levee slope damaged by foot traffic and prevent access where possible.					
Inspector Comment					
Footpath on the waterside slope.

View of slope stability on the waterside slope. Spring 2018.

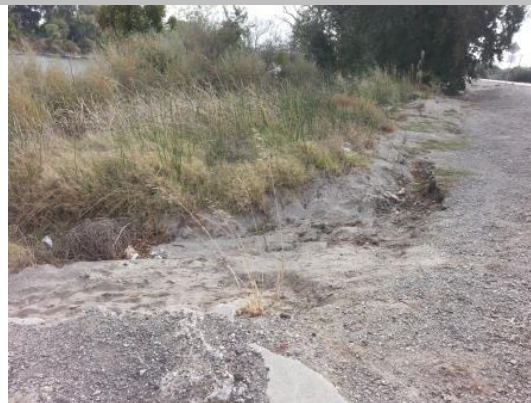
Photo 2 of 4 : SP\_2019\_RD0785\_185\_13\_20190304\_00009.jpg

View of the slope stability site. Fall 2016.

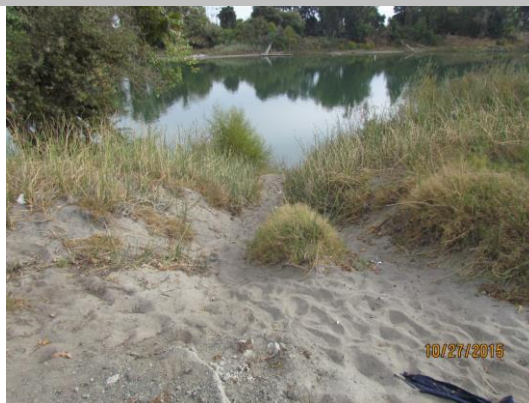
Photo 4 of 4 : SP\_2019\_RD0785\_185\_13\_20190304\_00011.jpg

View of the slope stability on the waterward side of the levee. Fall 2015.

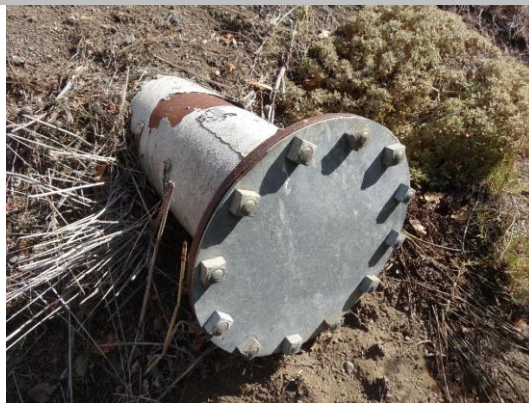
Photo 2 of 2 : UCIP\_SP\_2019\_41984\_44483.jpg

LS view: plate bolted pipe on levee slope.

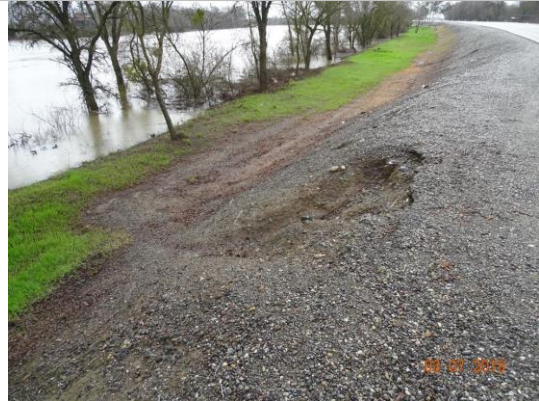
Photo 1 of 1 : SP\_2019\_RD0785\_185\_17\_20190311\_00039.jpg

LM Start	1.41	Rating **	M	Issue No.	17
LM End	1.41	Issue Type +	Ma	Location *	WS
Category	Earthen Levee			GPS Latitude/Longitude	
				Start	End
Item	Erosion / Bank Caving			38.645424 °	38.645424 °
				-121.597716 °	-121.597716 °
DWR ID	DWR_RD0785_01_s_2019_17				
Comment Code					
E2 : Schedule repair of erosion site prior to the next inspection.					
Inspector Comment					
Runoff erosion on the waterside slope.

View of runoff erosion on the waterside slope. Spring 2019.

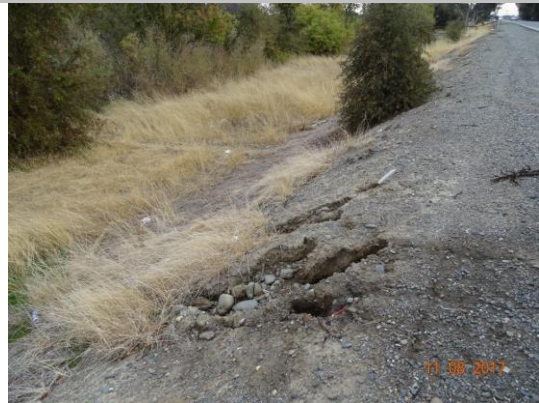
Photo 1 of 1 : SP\_2019\_RD0785\_185\_55\_20190304\_00024.jpg

LM Start	1.51	Rating **	M	Issue No.	55
LM End	1.51	Issue Type +	Ma	Location *	WS
Category	Earthen Levee			GPS Latitude/Longitude	
				Start	End
Item	Erosion / Bank Caving			38.644349 °	38.644349 °
				-121.596506 °	-121.596506 °
DWR ID	DWR_RD0785_01_f_2017_55				
Comment Code					
E2 : Schedule repair of erosion site prior to the next inspection.					
Inspector Comment					
Runoff on waterside slope.

View of the runoff erosion on the waterside slope. Fall 2017.

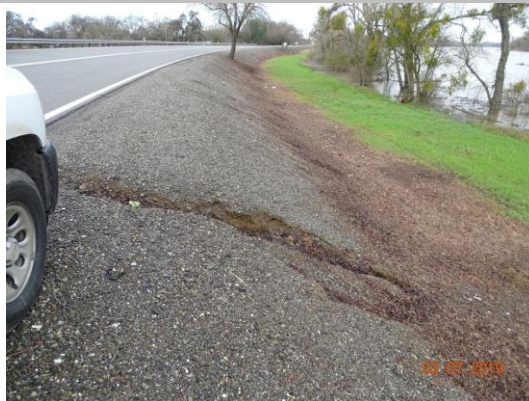
Photo 1 of 1 : SP\_2019\_RD0785\_185\_15\_20190311\_00038.jpg

LM Start	1.78	Rating **	M	Issue No.	15
LM End	1.78	Issue Type +	Ma	Location *	WS
Category	Earthen Levee			GPS Latitude/Longitude	
				Start	End
Item	Erosion / Bank Caving			38.642042 °	38.642042 °
				-121.592536 °	-121.592536 °
DWR ID	DWR_RD0785_01_s_2019_15				
Comment Code					
E2 : Schedule repair of erosion site prior to the next inspection.					
Inspector Comment					
Rills on the waterside slope.

View of rill on the waterside slope. Spring 2019.

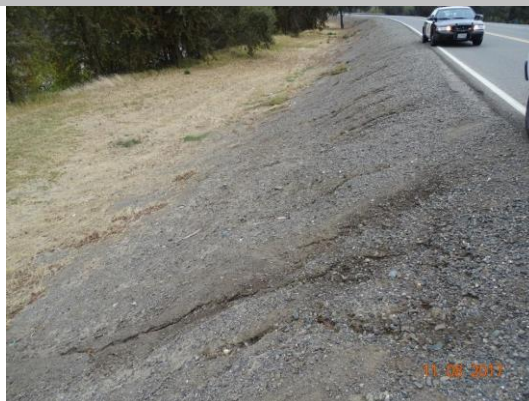
Photo 1 of 1 : SP\_2019\_RD0785\_185\_19\_20190304\_00014.jpg

LM Start	2.23	Rating **	A/W	Issue No.	19
LM End	2.23	Issue Type +	Ma	Location *	WS
Category	Earthen Levee			GPS Latitude/Longitude	
				Start	End
Item	Erosion / Bank Caving			38.642908 °	38.642908 °
				-121.584647 °	-121.584647 °
DWR ID	DWR_RD0785_01_s_2018_19				
Comment Code					
E1 : Note and monitor erosion site.					
Inspector Comment					
Runoff erosion on waterside slope. Recommend monitoring.

View of runoff erosion on the waterside slope. Fall 2017.

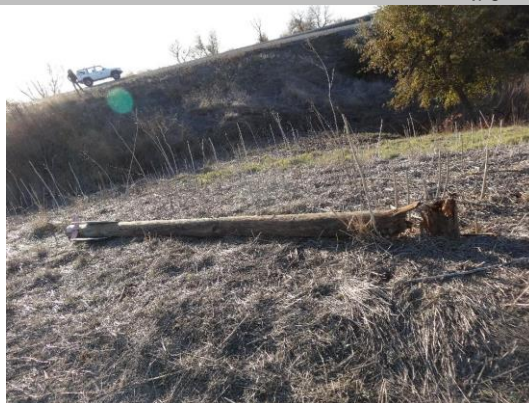
Photo 1 of 2 : UCIP\_SP\_2019\_24750\_44372.jpg

LM Start	0.01	Rating **	M	Issue No.	281	
LM End	0.01	Issue Type +	En	Location *		
Category	Supplemental			GPS Latitude/Longitude		
				Start	End	
Item	DWR UCIP Field Study			38.641086 °	38.641086 °	
				-121.620350 °	-121.620350 °	
DWR ID	22985					
Comment Code						
Inspector Comment						
FS_ID:24750 DS_ID:22985 EP_NO: 16982 Repair Type: Non-Urgent Crossing Status: Indicator Found UCIP Comments: Only a damaged indicator post found on landside across the road.Damaged indicator needs to be fixed. FIELD_STRUCT_DESC: Three 2-inch-diameter and three 1.5-inch diameter HDPE conduits containing fiber optic cables across and under the east levee (County Road 124), 67 feet below the crown. HDPE pipes were pulled through an 8-inch bore hole and backfilled with bentonite. (App. No. 16982 - Pacific Fiber Link) FS Date: 12/2/2013

LS view: damaged indicator post across the levee road.

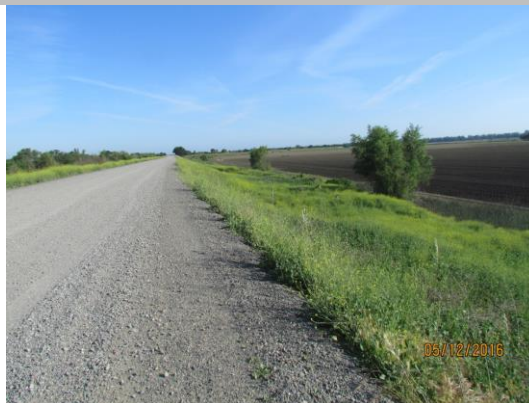
Photo 1 of 1 : SP\_2019\_RD0785\_186\_280\_20190304\_00005.jpg

View of the slope stability on the landward side of the levee looking upstream. Spring 2016.

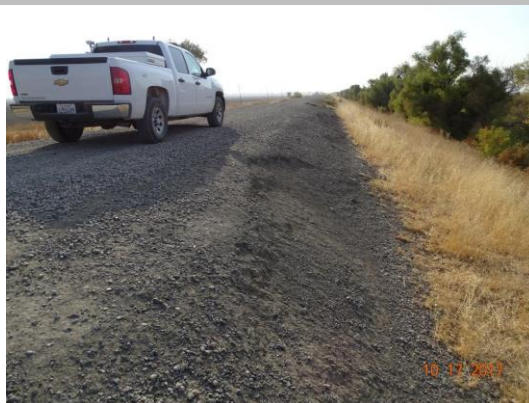
Photo 1 of 1 : SP\_2019\_RD0785\_186\_7\_20190304\_00002.jpg

View of sloughing section on waterside hinge point. Fall 2017.

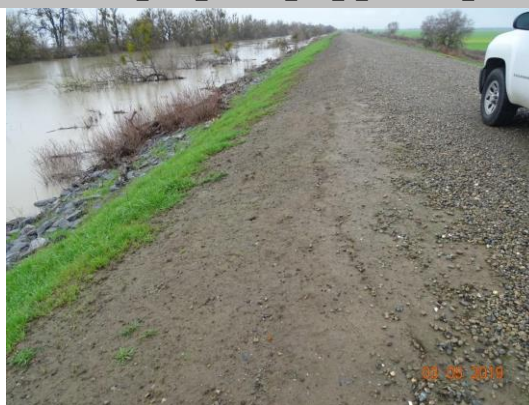
Photo 1 of 2 : SP\_2019\_RD0785\_186\_5\_20190311\_00008.jpg

View of crack on the waterside shoulder. Spring 2019.

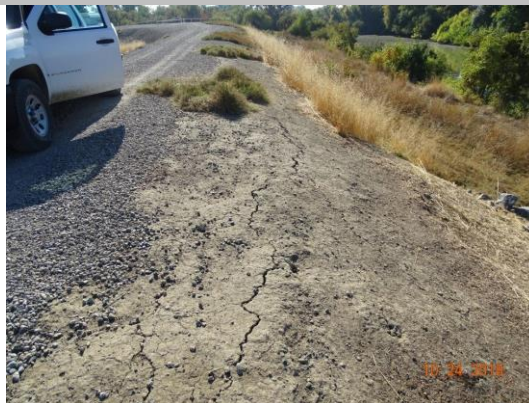
Photo 2 of 2 : SP\_2019\_RD0785\_186\_5\_20190304\_00001.jpg

View of cracks on the waterside shoulder. Fall 2018.
